PROPERTY INSPECTION REPORT

Report #: RF20100331-01

Concerning: 1313 Mockingbird Lane, McAllen, TX -

By: Richard Flores, #8139 03/31/2010 (Date)

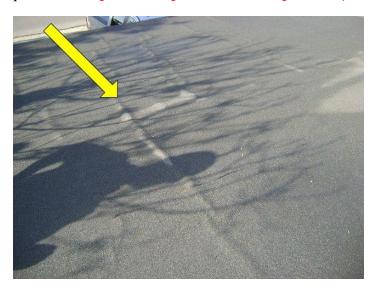
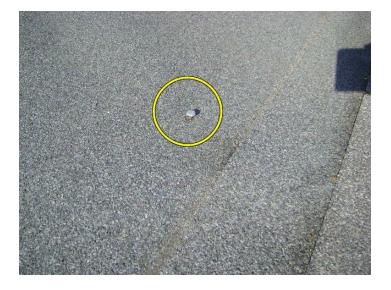
- b Carport covering is improperly installed with improper material. This must be corrected.
- b Vent flashings are damaged and are allowing water to penetrate into home.

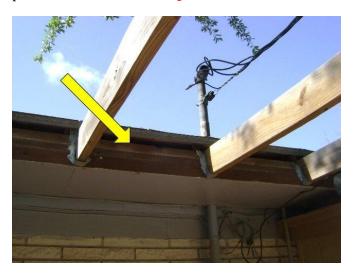
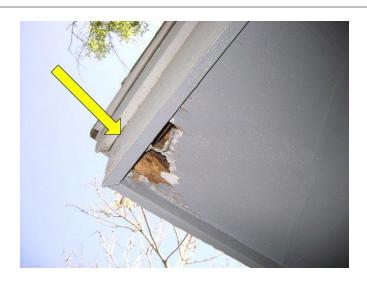
D. Roof Structure & Attic

- b Insulation levels are inadequate.
- b Signs of water penetration seen in various sections of roof rafters.
- b Facia and soffit are damaged in various locations and can allow for water &/or rodents to enter attic.

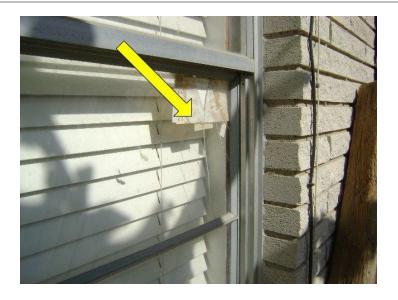
b Various broken windows seen in home.

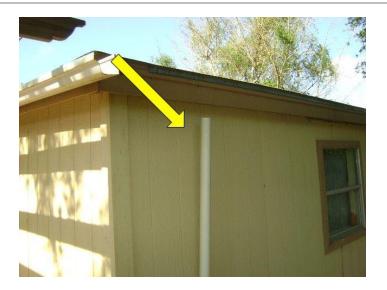
b Vents need to terminate above roof line.

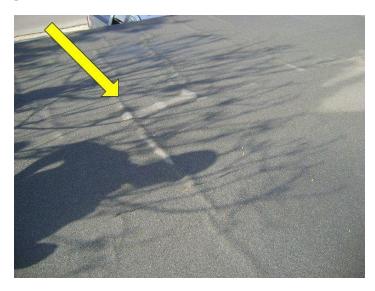
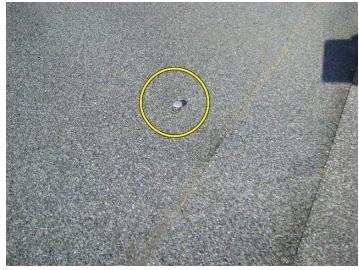
Roof Covering Materials

- b Carport covering is improperly installed with improper material. This must be corrected.
- b Vent flashings are damaged and are allowing water to penetrate into home.

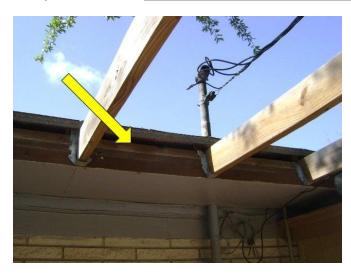
Roof Structure & Attic

- b Insulation levels are inadequate.
- b Signs of water penetration seen in various sections of roof rafters.
- b Facia and soffit are damaged in various locations and can allow for water &/or rodents to enter attic.

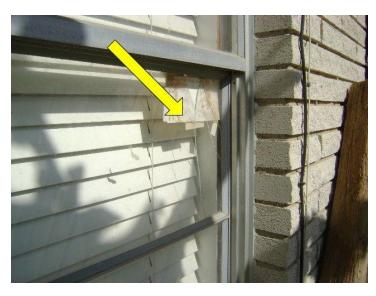
Windows

b Various broken windows seen in home.

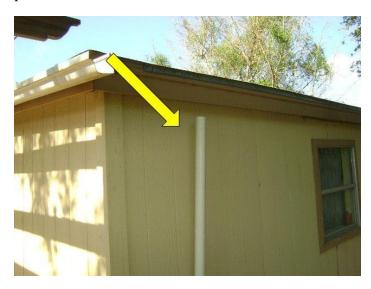
Drains, Wastes, and Vents Note:only visible and accessible waste lines are checked

b Vents need to terminate above roof line.
